Indoor Air Pollution at the Jerusalem Central Bus Station 2014-2017

Geula Sharf¹, Dafna Alper Simantov², Illan Shapir¹, Tal Kushnir¹ and Mordechai Peleg³

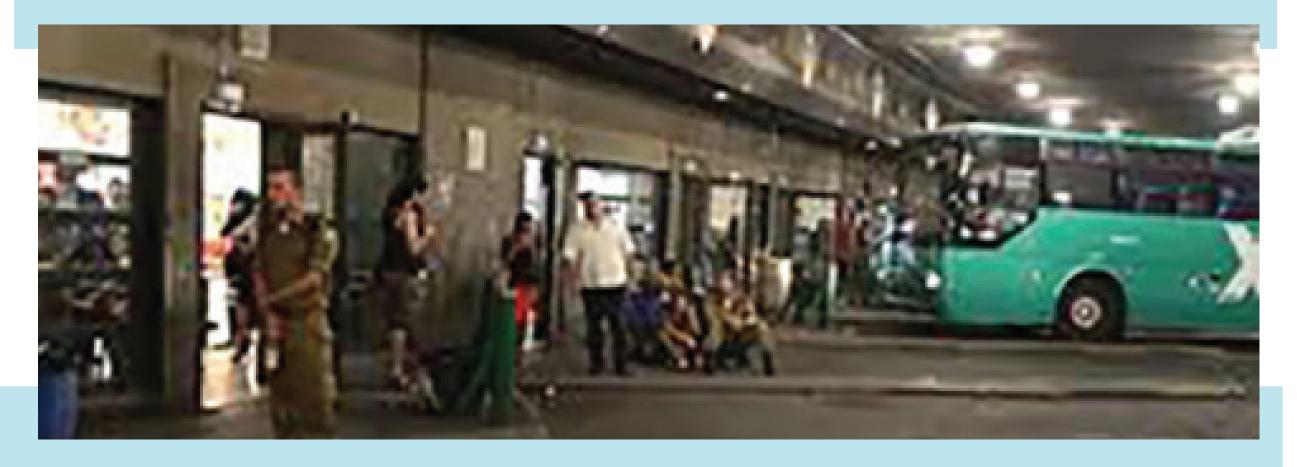
Figure 2 shows the improvements of the ventilation system at the JCBS: A significant decrease in $PM_{2.5}$ annual concentration in 2017 (18µg/m³) as compared to the concentrations measured in 2014 (38µg/m³). The annual concentrations on the rooftop of the station did not show significant changes during the measured period and reached maximum level of 19µg/m³.
